Manhole Inspection Summary

Manhole # S15U__006MH

Location Address: **1120 WHISTLER AV** Cross Street: **WILMARCO AV**

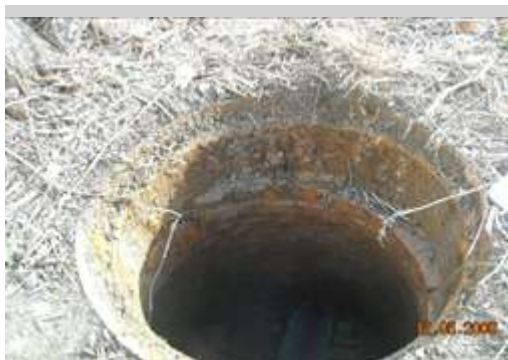
MISC.

Manhole Type: **Inline** Location: **Grass** Ground Conditions: **Dry**
☐ Prev. Rehab Weather: **Dry** Subject To Ponding: **Sheeting**

INFLOW EVIDENCE FROM SHEETING

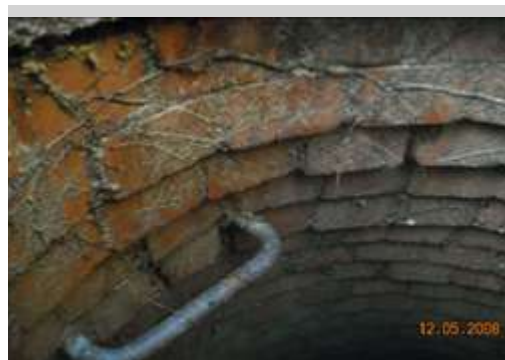
Defect 2

Corbel Material: **Brick** ☐ Parged Type: **Concentric/Eccentric**
Condition: ☐ Sound ☐ Cracked ☒ **Root Intrusion** ☐ Loose Brick ☐ Deteriorated
Infiltration: ☒ None ☐ Joint ☐ Cracks ☐ Mortar ☐ Roots ☐ Wall

ROOT INTRUSION @ CORBEL WALL

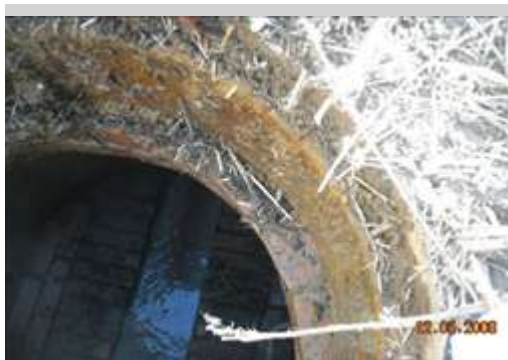
Defect 1

Frame Offset: **2** (in.) Condition: ☒ Sound ☐ Cracked ☐ Leaks

FRAME OFFSET

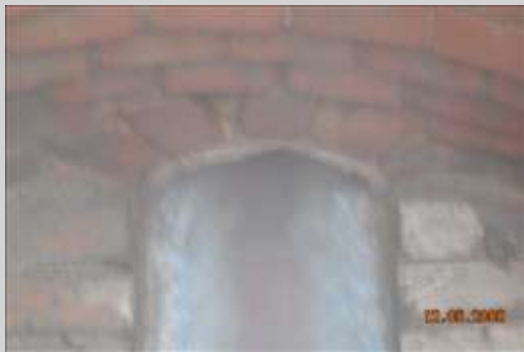
12 O'Clock Outflow

8 in. Circular Gravity Sewer
Pipe Out @ 12 O'Clock

Pipe Height: **8.4** (in.) Rod and Bar (Angled)
Pipe Material: **Clay** ☐ Pipe Lined
Invert Depth: **5.47** (ft.) Flow Characteristics: **Slow**
Deposits: ☒ None ☐ Mud ☐ Sludge ☐ Debris ☐ Grease
Silt Depth: **0** (in.) Deposits Extent:
Infiltration: **None** Pipe Seal Cond: **Sound**

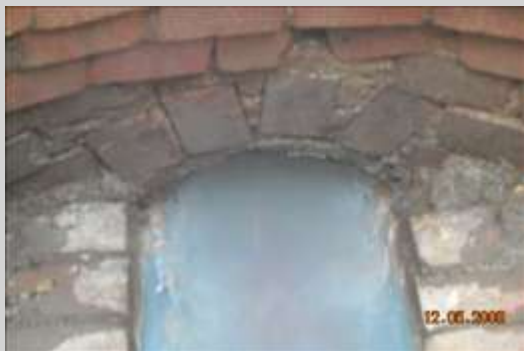
6 O'Clock Inflow

8 in. Circular Gravity Sewer
Pipe In @ 6 O'Clock

Pipe Height: **8.4** (in.) Rod and Bar (Angled)
Pipe Material: **Clay** ☐ Pipe Lined
Invert Depth: **5.39** (ft.) Flow Characteristics: **Slow**
Deposits: ☒ None ☐ Mud ☐ Sludge ☐ Debris ☐ Grease
Silt Depth: **0** (in.) Deposits Extent:
Infiltration: **None** Pipe Seal Cond: **Sound**
